## EVALUATION OF THE EXTERNAL FIRE RESISTANCE CHARACTERISTICS OF ROOF COVERING SYSTEMS IN GENERAL ACCORDANCE WITH ASTM E 108-10a, *STANDARD TEST METHODS FOR FIRE TESTS OF ROOF COVERINGS*: CLASS A

**SAMPLE ID:** *AATIS/FR Panel*

**FINAL REPORT**  
Consisting of 27 Pages

**SwRI® Project No. 01.15677.01.001**  
**Test Date: August 26, 2010**  
**Report Date: September 14, 2010**

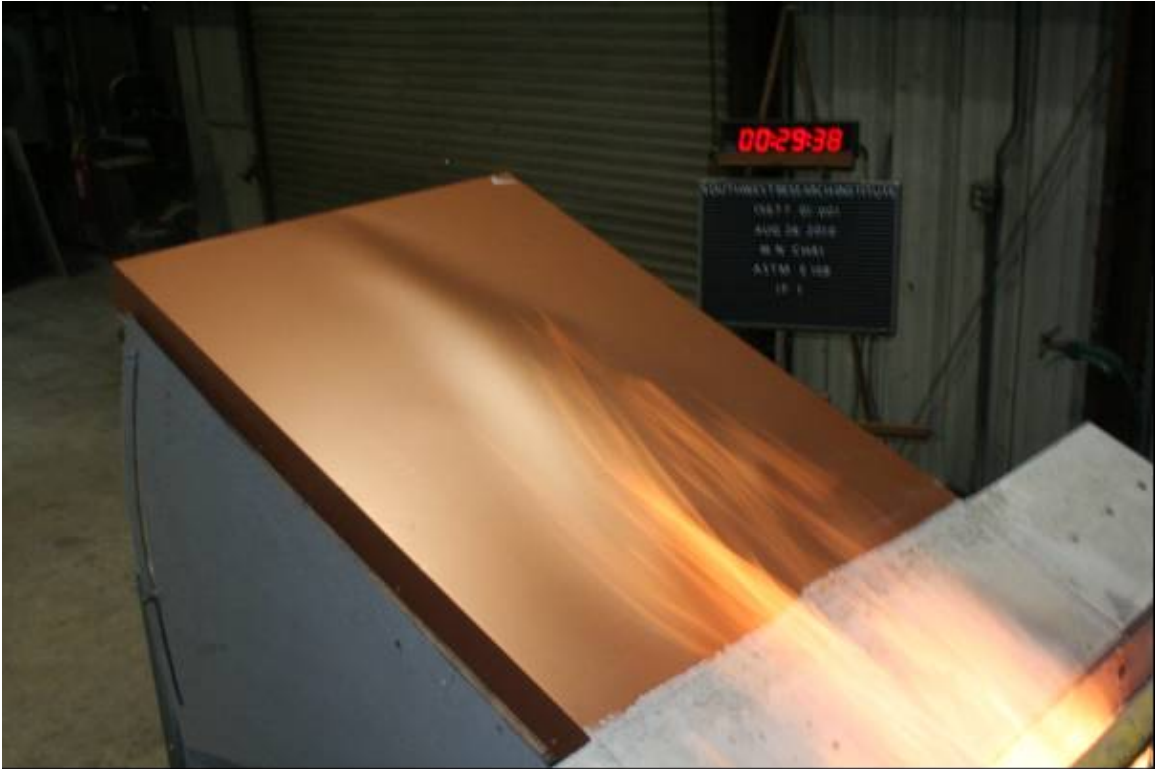
**Figure B-1. Test ID IF-1. Top Side of Test Sample at 29 min 38 s.**

Test ID No.: IF 1 of 2  
 Specimen ID: AATIS/FR Panel  
 Ambient Air Temperature: 82.9 °F (28.3 °C)  
 Deck EMC: N/A  
 Slope: 5:12

| <b>TIME<br/>MIN:S</b> | <b>OBSERVATIONS</b> |
|---|---|
| 58:00 | Cycle #15 complete. No change. Test stopped. No failure conditions present. <b>PASS.</b> |

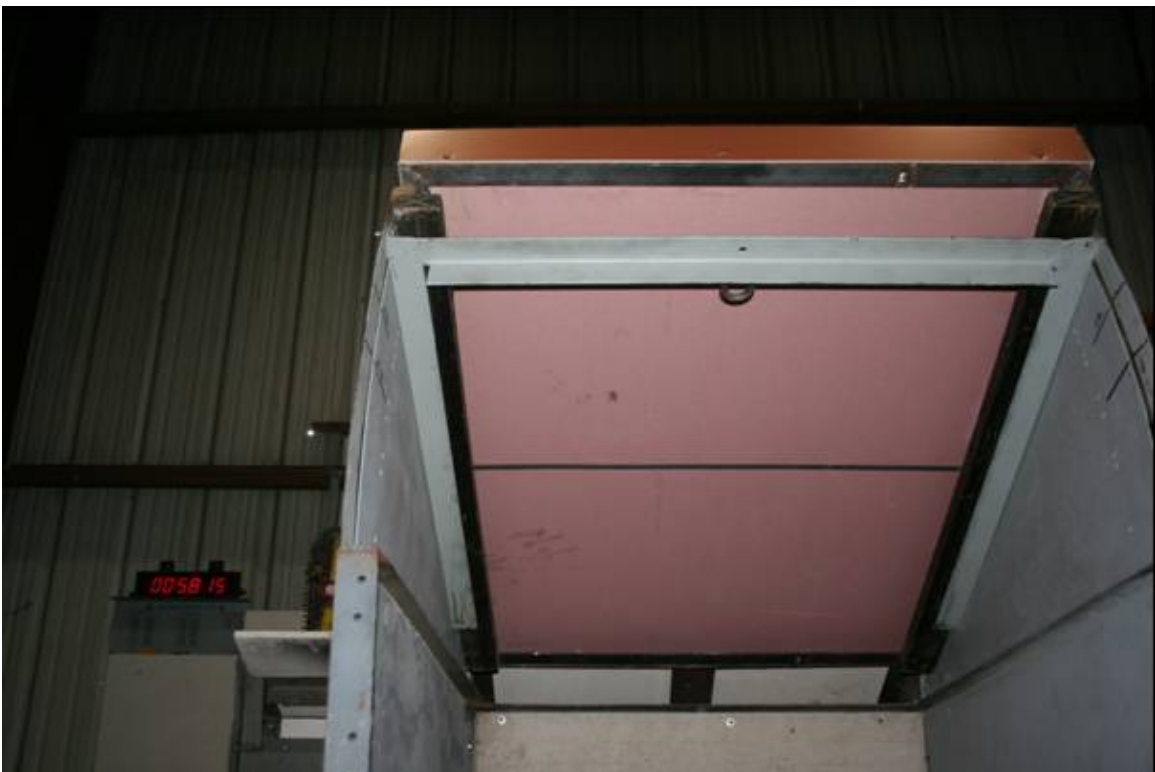
**Figure B-2. Test ID IF-1. Underside of Test Sample at End of Test.**

| <b>TIME<br/>MIN:S</b> | <b>OBSERVATIONS</b> |
|---|---|
| 34:00 | Cycle #9 complete. Bowing remains in top skin of deck. No changes visible on underside of deck. |

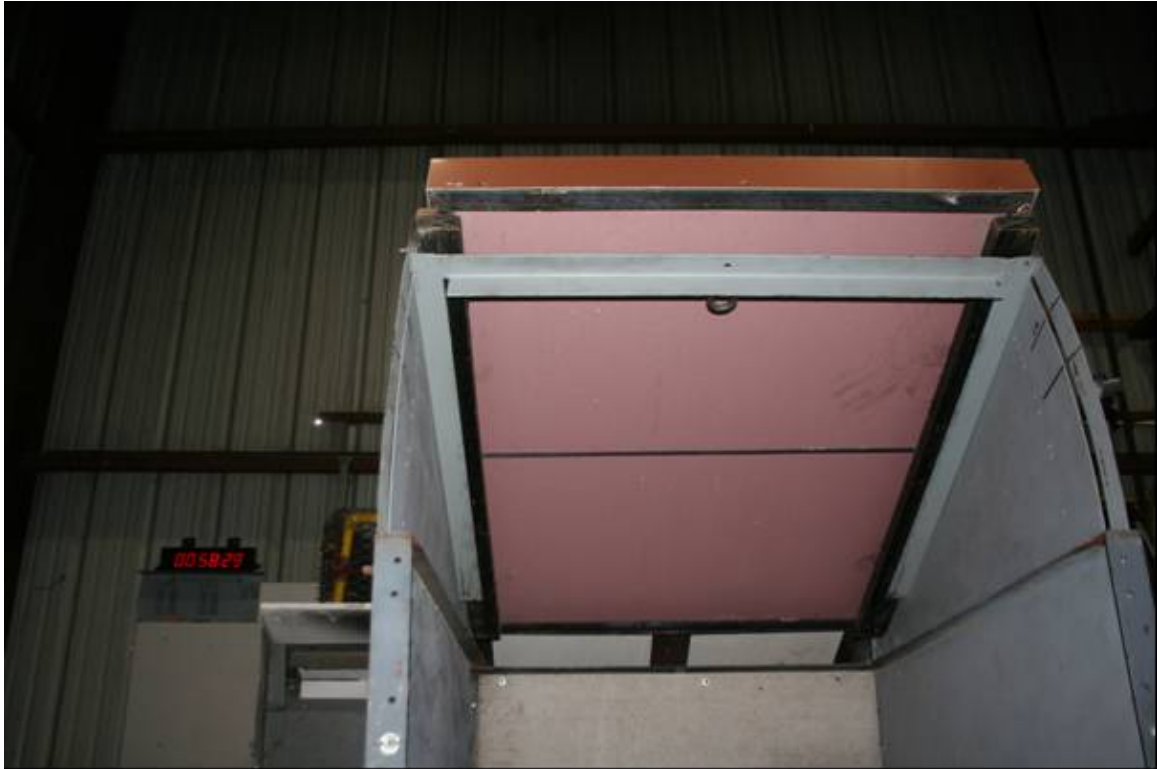
**Figure B-3. Test ID IF-2. Underside of Test Sample at End of Test.**

| <b>TIME<br/>MIN:S</b> | <b>OBSERVATIONS</b> |
|---|---|
| 34:00 | Cycle #9 complete. No visible changes to underside of deck. |
| 58:00 | Cycle #15 complete. No change. Test stopped. No failure conditions present. <b>PASS.</b> |

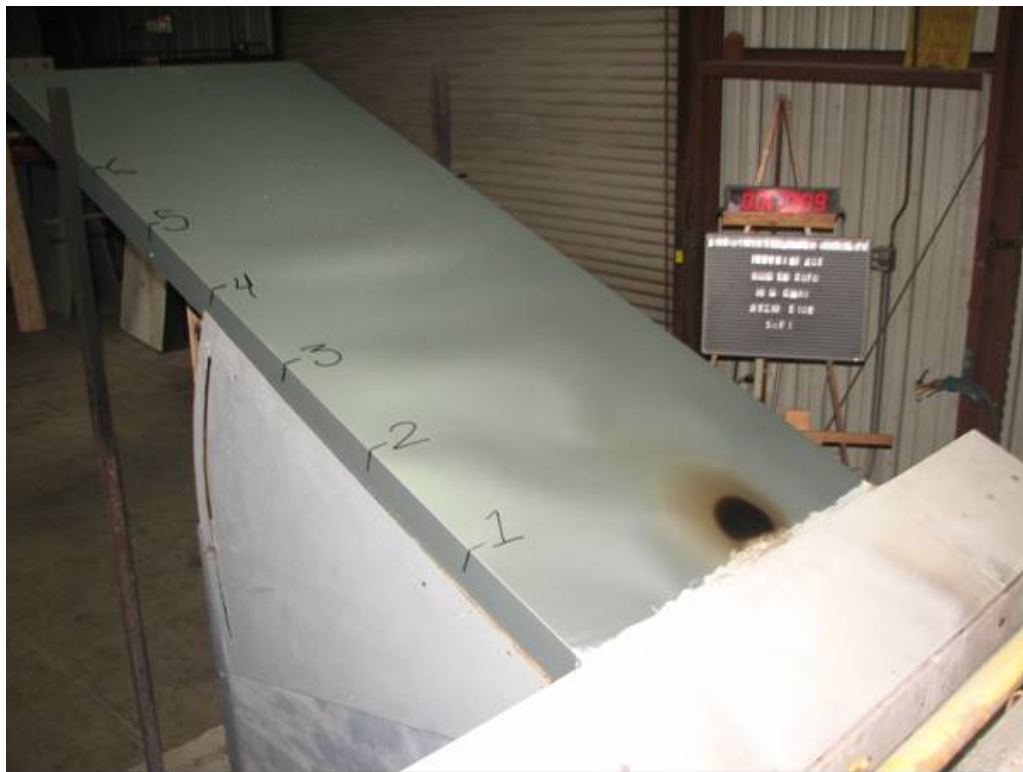
**Figure B-4. Test ID SoF-1. Test Sample at End of Fire Exposure.**

| <b>TIME<br/>MIN:S</b> | <b>OBSERVATIONS</b> |
|---|--|
| 01:05 | Bowing of top skin of panel becoming visible. |
| 01:20 | Bowing in panel skin reaches approximately 1 ft 6 in. |
| 05:00 | Bowing in panel skin reaches approximately 2 ft 6 in. |
| 06:50 | Small area of discoloration visible at front edge of panel. |
| 10:00 | Test stopped. No ignition of exposed surface at any point. <b>PASS</b> |

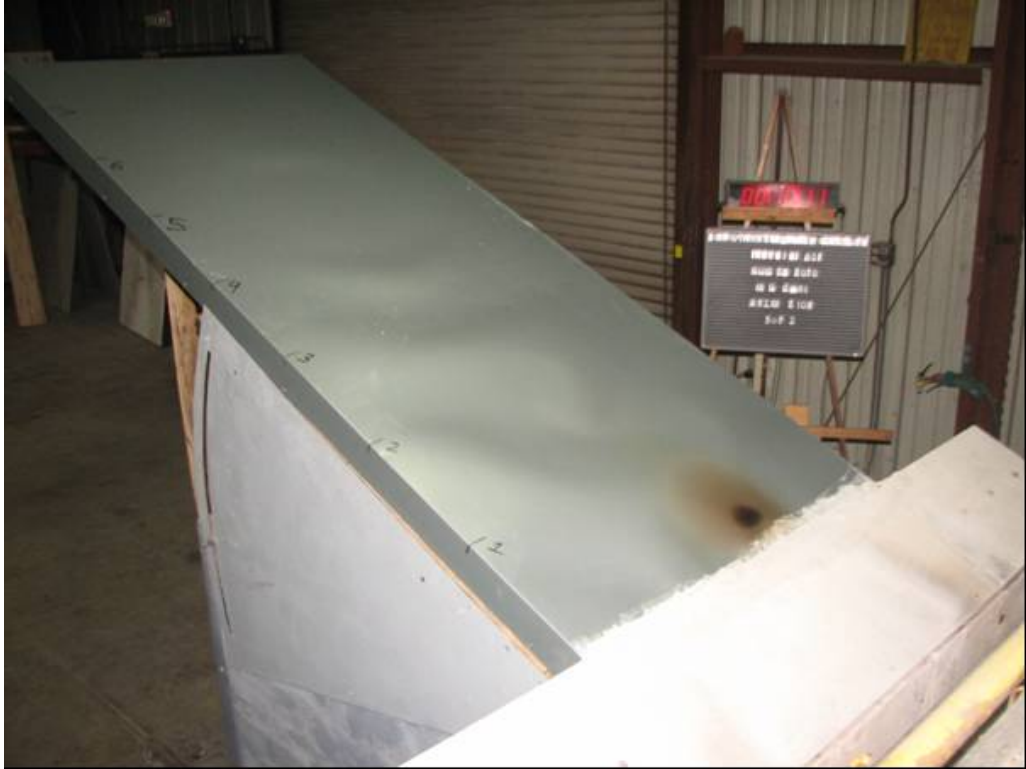
**Figure B-5. Test ID SoF-2. Test Sample at End of Test.**

| TIME<br>MIN:S | OBSERVATIONS |
|---|---|
| 04:11 | Bowing of panel skin in first 3 ft of deck. |
| 10:00 | Test terminated. No ignition of panel surface at any point. <b>PASS</b> |

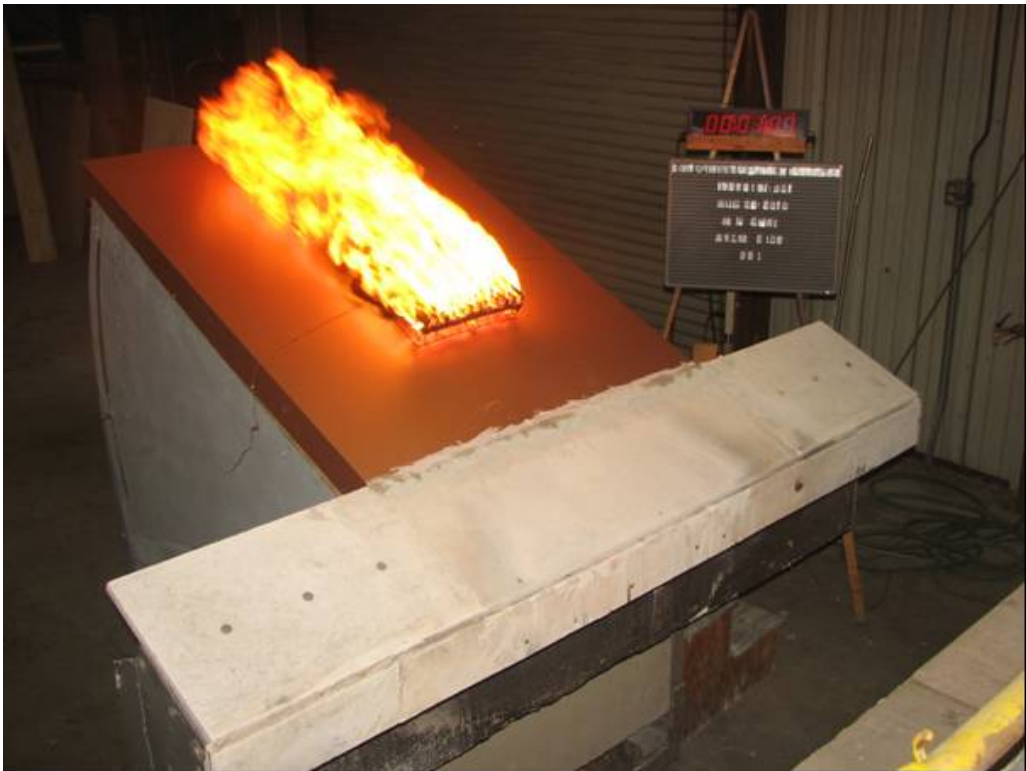
**Figure B-6. Test ID BB-1. Typical Brand Placement.**

Test ID No.: BB 1 of 4  
Specimen ID: *AATIS/FR Panel*  
Ambient Air Temperature: 93.1 °F (33.9 °C)  
Deck EMC: N/A  
Brand Weight: 1929 g (4.25 lb)

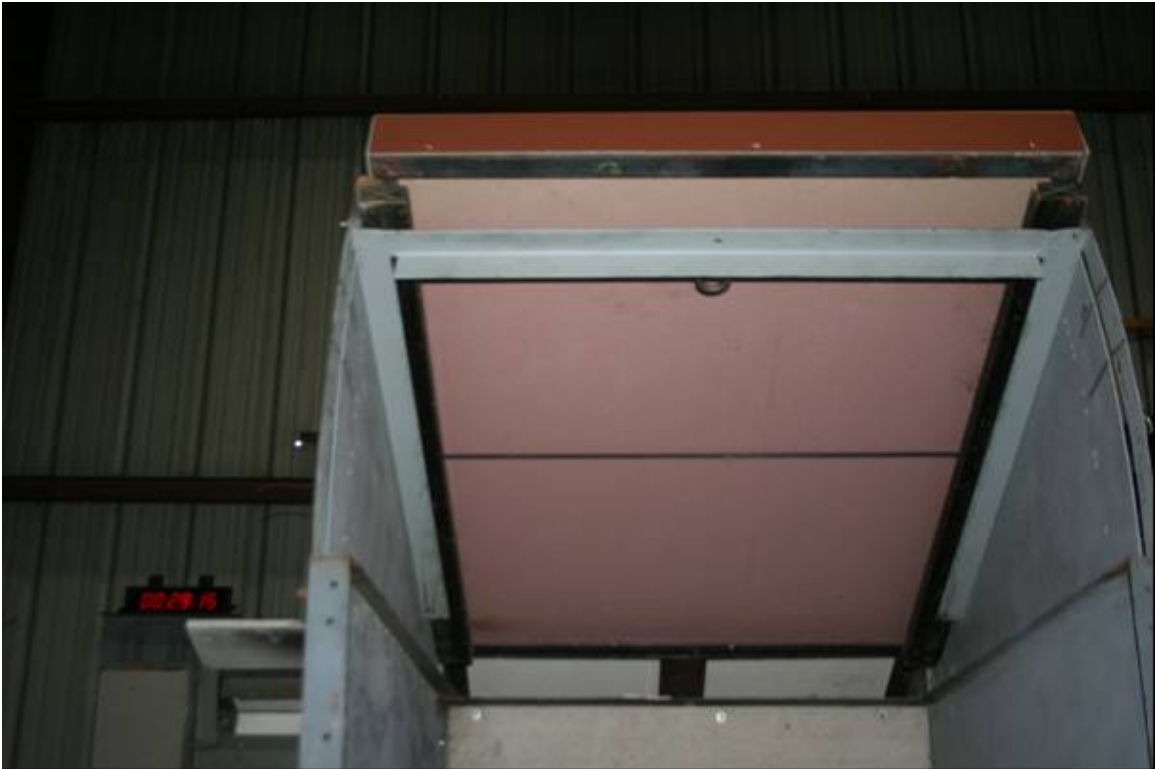
**Figure B-7. Test ID BB-1. Underside of Test Sample at End of Test.**

| <b>TIME<br/>MIN:S</b> | <b>OBSERVATIONS</b> |
|---|--|
| 25:00 | Flaming from brand and glowing embers completely extinguished. No visual changes to underside of deck. |

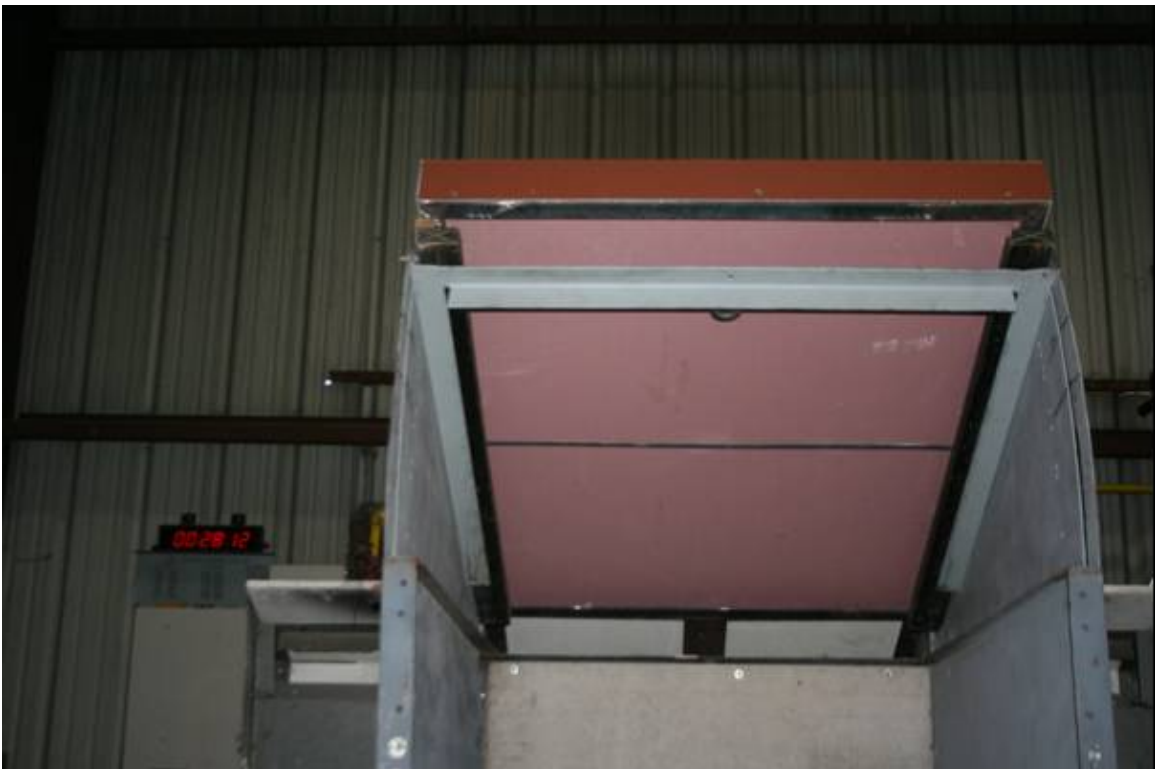
**Figure B-8. Test ID BB-2. Underside of Test Sample at End of Test.**

| <b>TIME<br/>MIN:S</b> | <b>OBSERVATIONS</b> |
|---|---|
| 25:00 | All embers on top side of deck extinguished. No changes to underside of deck. |

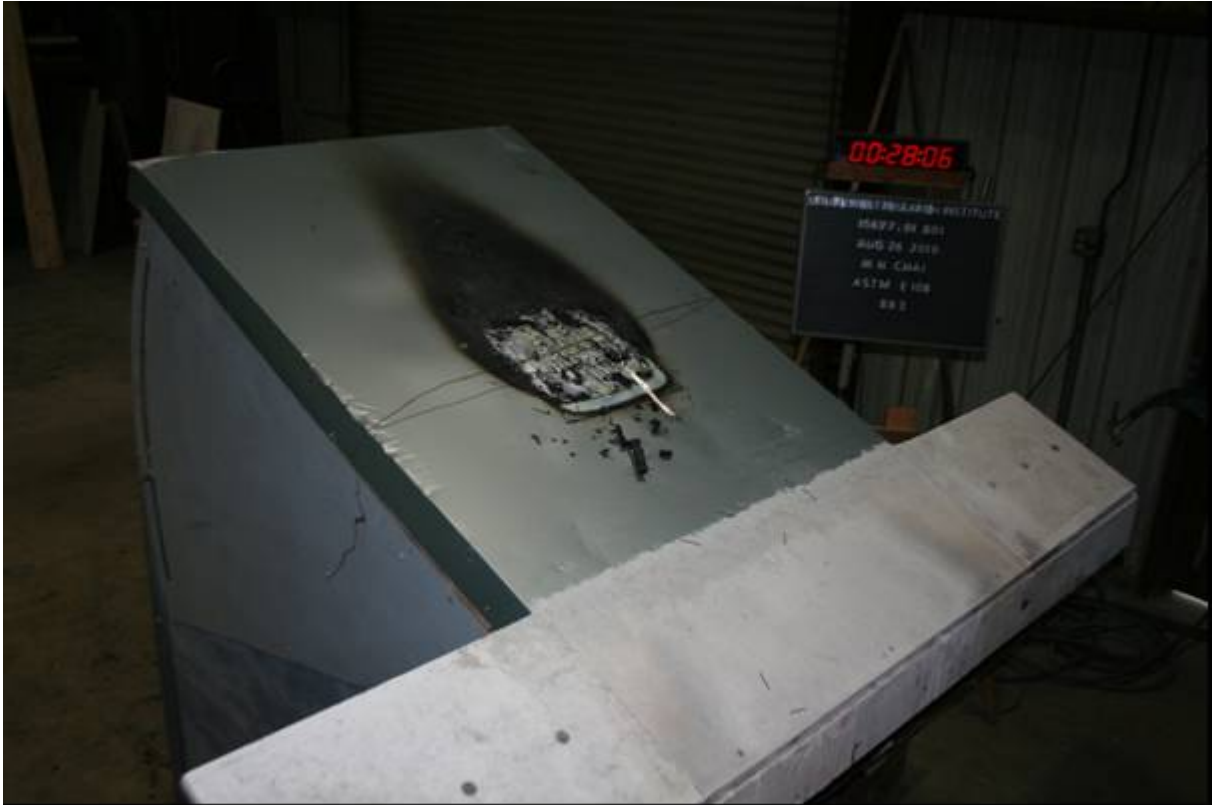
**Figure B-9. Test ID BB-3. Top Side of Test Sample at End of Test.**

| <b>TIME<br/>MIN:S</b> | <b>OBSERVATIONS</b> |
|---|--|
| 24:25 | All embers on top surface of deck extinguished. No changes to underside of deck. |

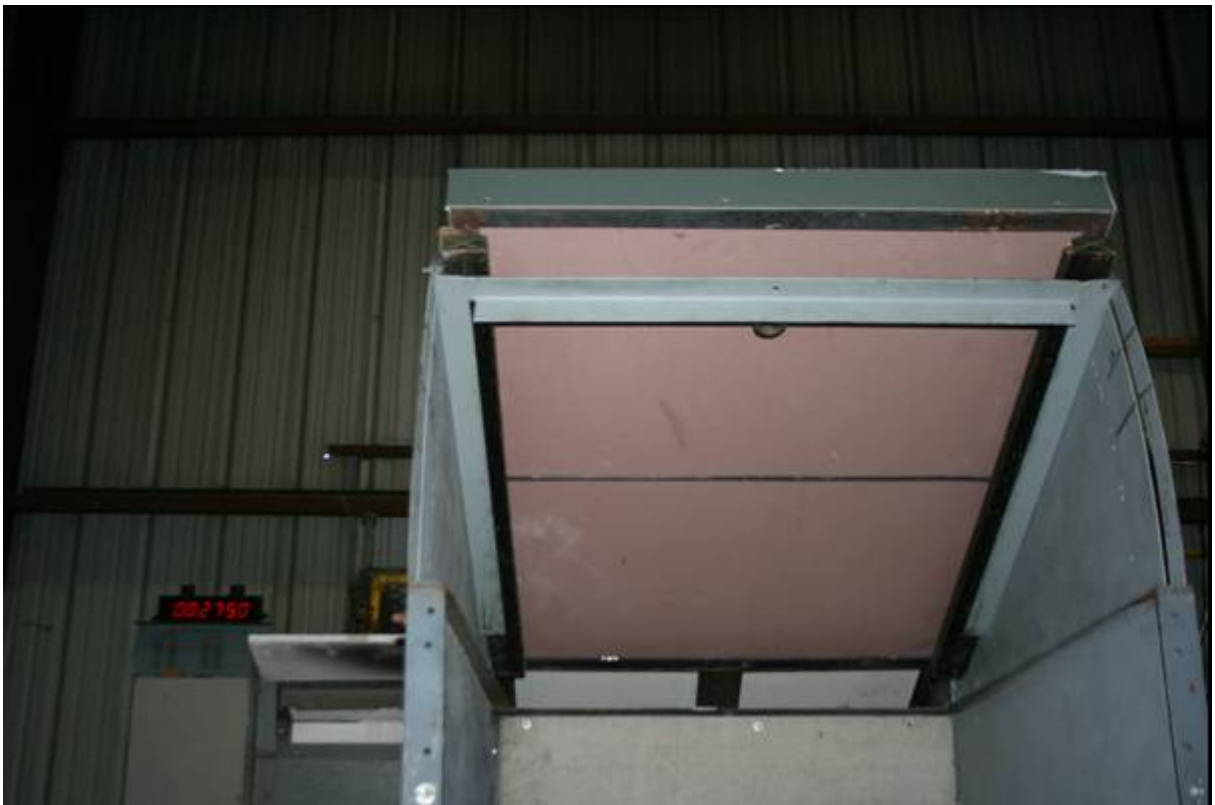
**Figure B-10. Test ID BB-3. Underside of Test Sample at End of Test.**

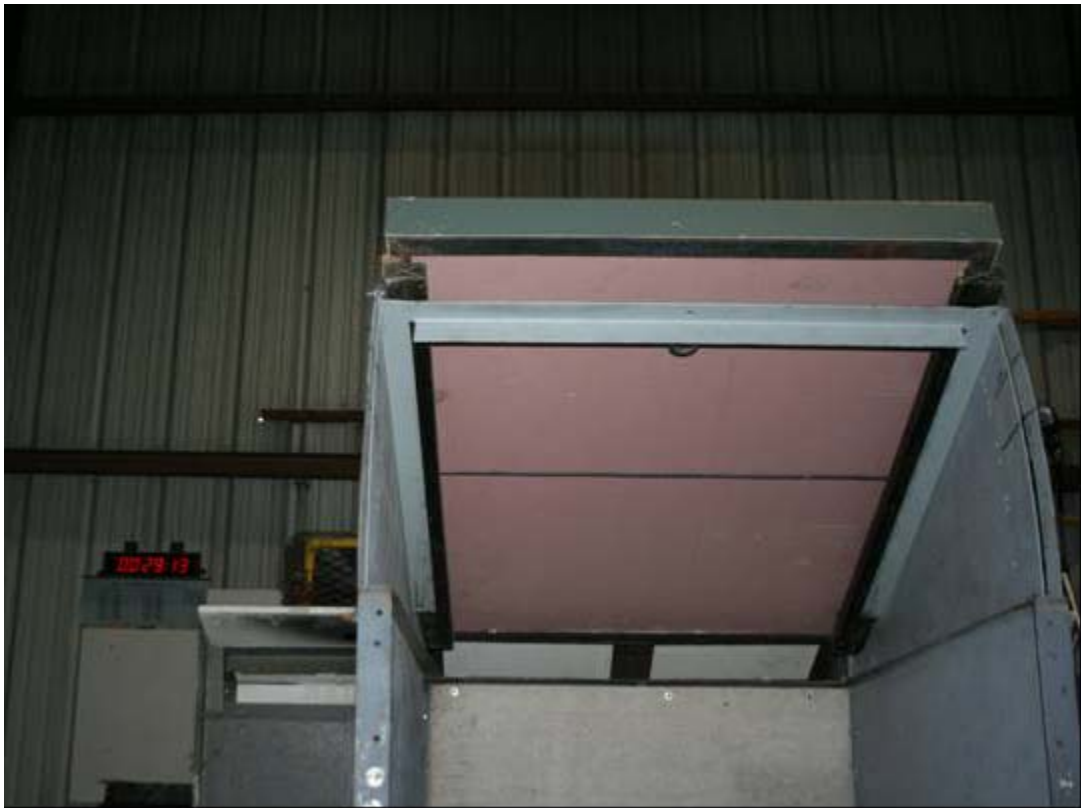
**Figure B-11. Test ID BB-4. Underside of Test Sample at End of Test.**

| <b>TIME<br/>MIN:S</b> | <b>OBSERVATIONS</b> |
|---|---|
| 21:20 | Small ember remains on top surface of deck. No changes to underside of deck. |

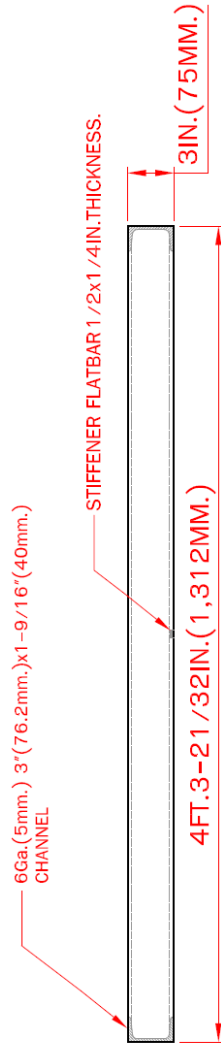
SIDE VIEW

CHANNEL STEEL STUD SUPPORT FRAME FOR ROOF ASSEMBLING ASTM E108

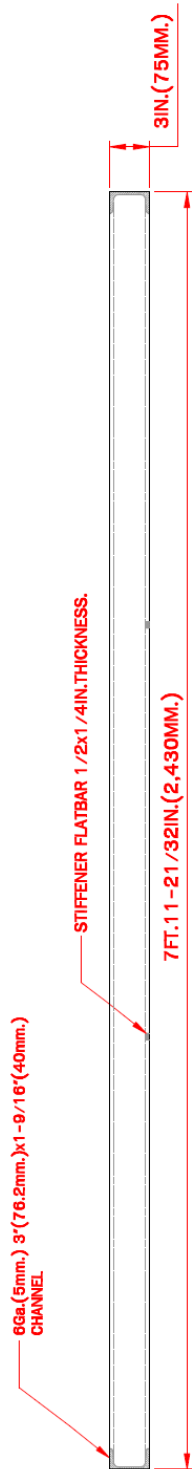
SIDE VIEW

### CHANNEL STEEL STUD SUPPORT FRAME FOR ROOF ASSEMBLING ASTM E108
